DuPont 2018 Field Analysis

PV Reliability

DuPont Global Field Reliability Program

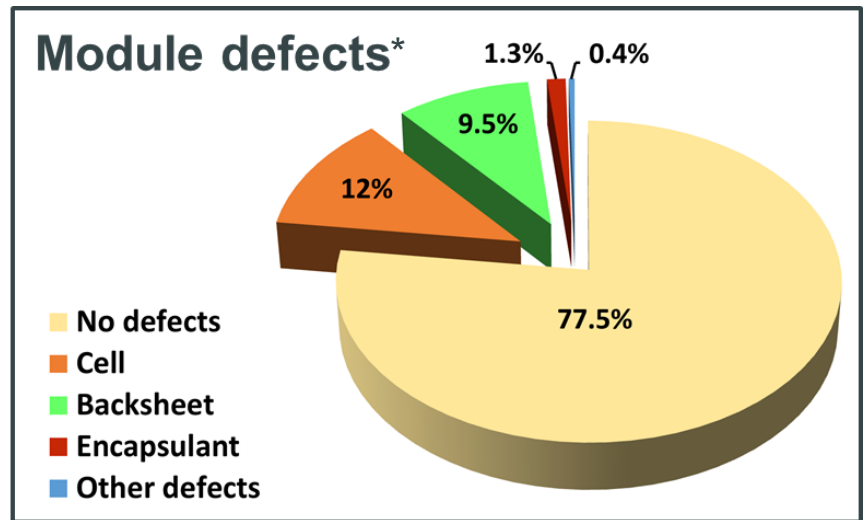
- Over 1 GW of fields inspected
- Total module defects 22.3%; backsheet defects 9.5%
- Backsheet defects increased by 27%
- Polymer defects: hot > tropical > temperate
- Work highlighted and cited in 2018 DNVGL PV Module Reliability Scorecard

Cell/interconnect: corrosion, hot spot, snail trails, broken interconnect, cracks, burn marks

Backsheet: cracking, delamination, yellowing, inner layer crack

Encapsulant: discoloration, browning, delamination

Others: glass defects, loss of AR coating, junction box

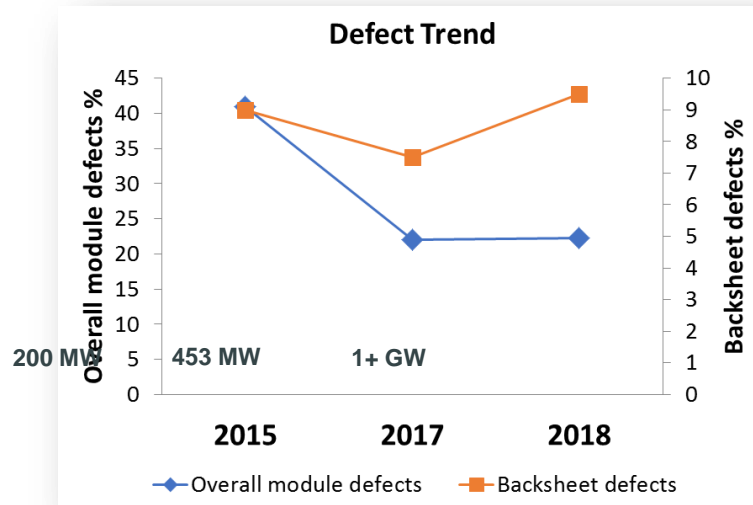
Defect Rates

- Module defect rates unchanged from 2017
- Backsheet defects increased 27% from 7.5% to 9.5%

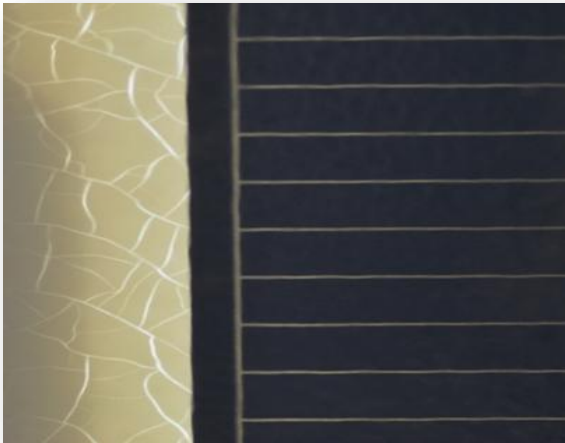
Inner Layer Cracking of PET Backsheet

- Backsheet inner layer cracked all over modules in spaces between cells and edges
- 30% power loss in 5 years, 6% loss per year
- Similar defects showing up in two continents

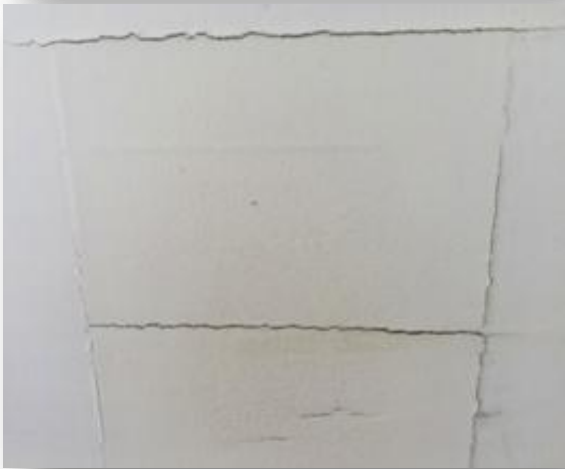
Outer Layer Cracking of Polyamide Backsheet

- Global failure estimated at >10 Gw
- 3-4 years service
- Safety issue and power loss due to inverter tripping

- Unproven materials can increase risk and lead to large failures
- Existing tests were / are not adequate to predict and prevent these failures
